16TH JULY, 2013 LANDSLIDE OCCURRED IN VILLAGE KOTI GAAD IN TEHRI GARHWAL, INDIA- AN ASSESSMENT OF LANDSLIDE CONSEQUENCES

VIDYA SAGAR KHANDURI, ANUPAM MITTAL

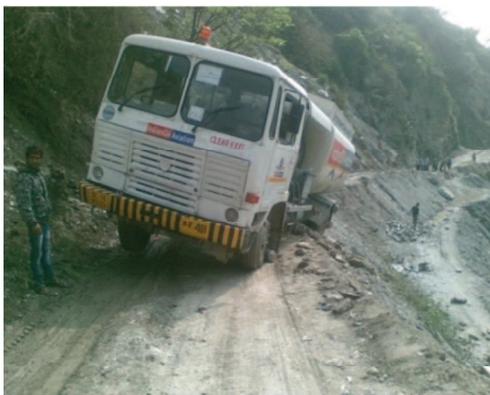
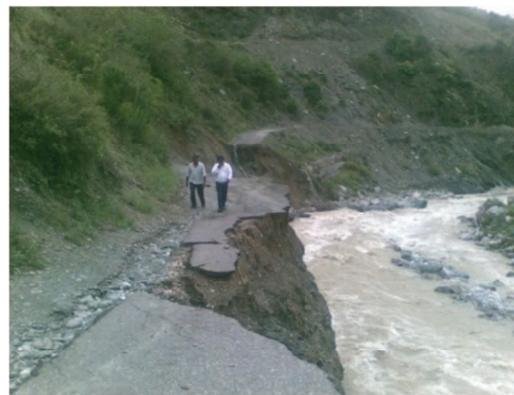
Figure 2 Trapped a vehicle while crossing landslide zone. [A]and Full Road flows with debris.[B]

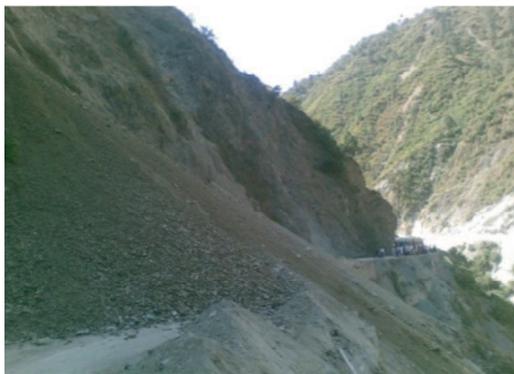
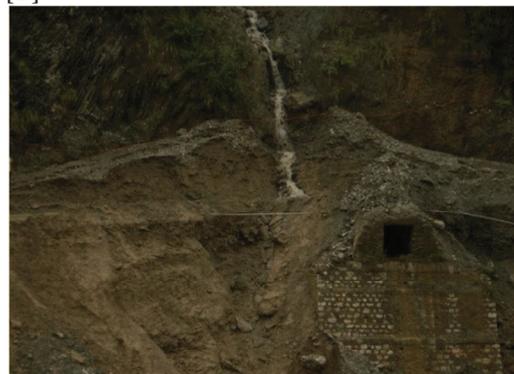
Figure 3 Blockade of Highway due to large volume of debris generated. [C] and Fall of stone from uphill.[D]

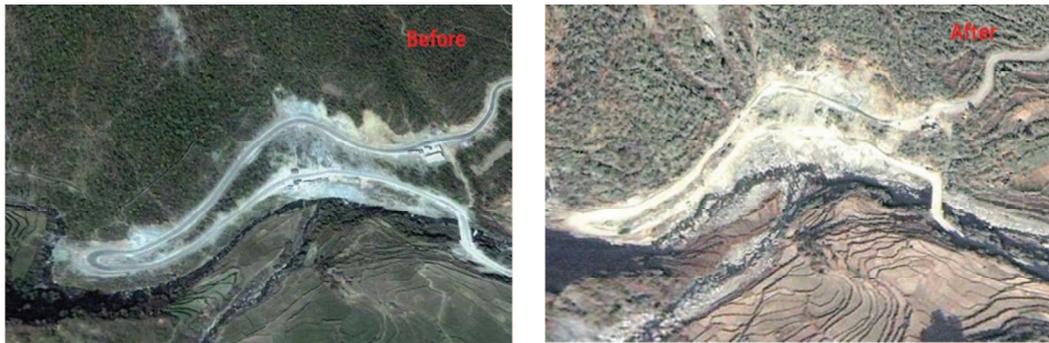
Figure 4 Pre- (left) and post- (right) landslides images showing damaged road during rainfall.

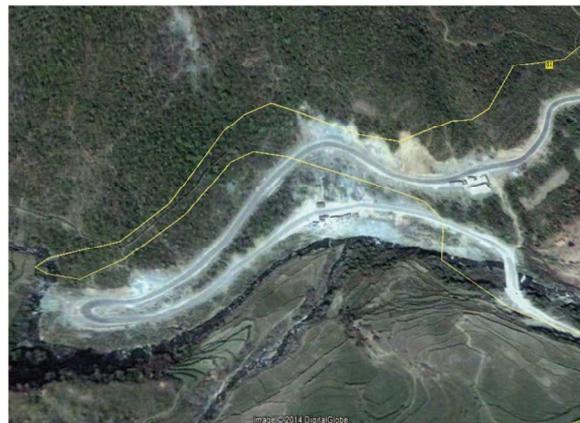
Figure 5 Old alignment as a road itself and new alignment in yellow line.
